WORLD CEMENT

The Silver Lining

Dexter Williams and Dean Green, Wear-Concepts, Inc., USA, review how finding the right solution for a very persistent wear-problem came to be seen as a silver lining in a granulated blast furnace slag grinding system in the Midwest, USA.

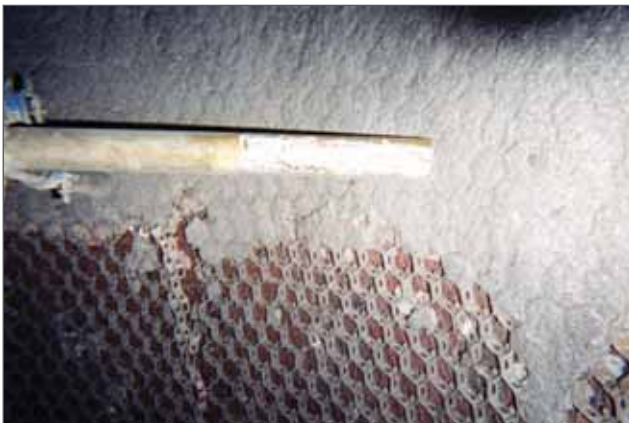
Figure 1. Material worn through.

Numerous repairs had been attempted, but the repairs amounted to basically applying more repair material to the worn areas, which only compounded the wear-problem and resulted in more costly downtime. This particular slag grinding system handled

material on a relatively large scale with a feed rate of 85 stph (actual material feed) and a velocity of 18 - 22 m/s up the shaft, so it was crucial that the new solution eliminated as much unnecessary downtime as possible. At one point, 50% of the worn liner was missing from the elbow at the top of the dryer shaft and the roof showed wear as well. Therefore a longer lasting solution was sought and Wear-Concepts, Inc., a specialist in normal day to day wear-problems as well as tough to solve wear problems, was selected.

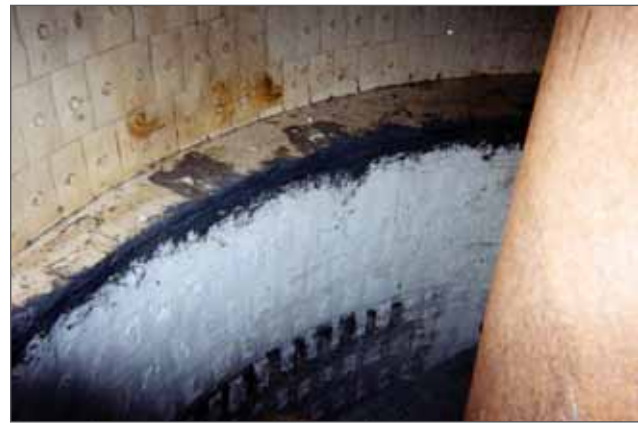
Figure 2. Installed WC90 ceramic.

To begin the ceramic installation, an initial 'starter row' was put in at the base of the shaft, keeping it level in order to serve as a guide for the rest of the linings that would line the walls for seven storeys. Each brick had to be spot-welded to the surface of the wall and then a ceramic cap inserted into the hole where the weld was located. The cap was then sealed with silicone, as were all the edges and joints. Keeping warm with heaters placed strategically every few floors, the crew worked their way methodically

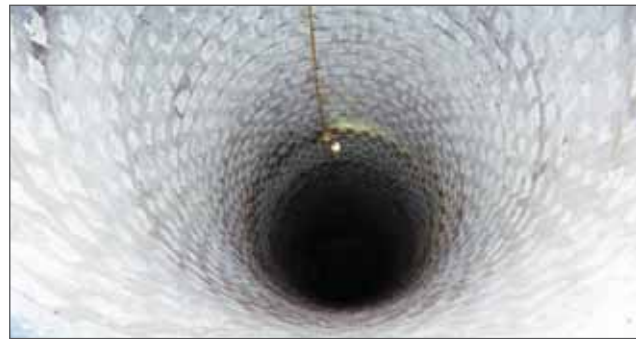
Figure 4. New lining in cyclone.

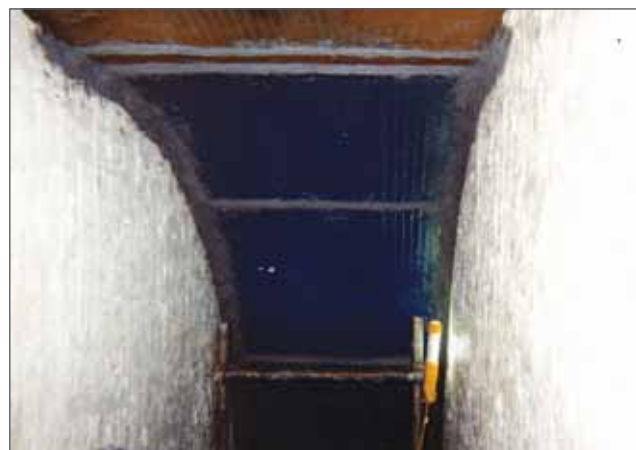
Figure 5. Inside view of custom engineered WC700 liner.

Figure 6. Outside view of custom engineered WC700 liner.

up the dryer shaft until they reached the impact zone of the elbow at the top of the shaft. Here, they installed a customised pre-engineered replaceable piece of WC700 chrome carbide, 1 in. thick wear plate (Figures 5 and 6). This piece was bolted into place so that the same custom part could easily be replaced in the future if necessary. The crew then moved into the large cylindrical-shaped cyclone which measured approximately 11 ft across and 16 ft in height. The special scaffolding system allowed them to access all of the sidewalls and install and seal the balance of the ceramic tile.

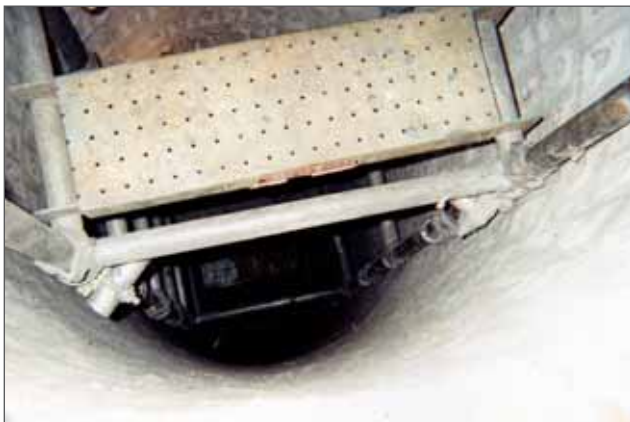
Figure 3. View looking down dryer shaft.

The first step in the planning and execution stages of installing the new liner was to determine which scaffolding system could best allow workers to move freely up the dryer shaft and still have plenty of room to pass materials through and to work in such a confined area. Due to the short time interval from start to finish, the

decision was made to hire a scaffolding crew and have it put in place at the onset of the job (Figure 3). The next consideration was to accurately determine the quantity of each material (WC90 Ceramic, silicone, etc.) required. It was estimated during the costing phase that approximately 15 000 WC90 ceramic tile pieces would be used, so that much, plus a little overage, was shipped in.

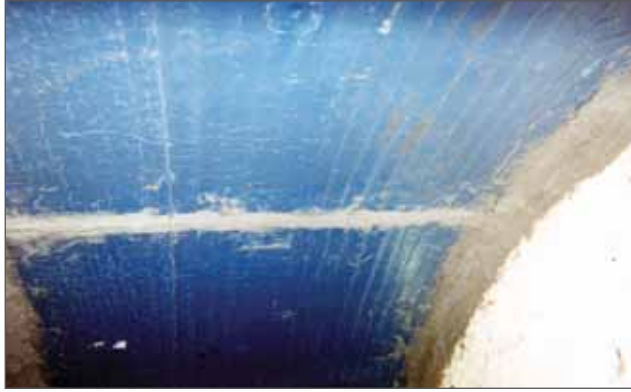
Figure 7. Close up of WC700 liner.
